WORLD WAR II GERMAN  
FIRE DOCUMENT TRANSLATIONS

## **WORLD WAR II GERMAN FIRE DOCUMENT TRANSLATIONS**

REPORT OF THE REGIMENTAL COMMANDER OF THE FIRE-PROTECTION POLICE REGIMENT "SAXONY" ABOUT THE COURSE AND RESULTS OF THE MASSIVE AERIAL ATTACKS ON ROTTERDAM ON MAY 14, 1940, AND THE EXPERIENCES DRAWN THEREFROM (by Hans Rumpf) . . . . .	A-1
The Air Defense Fire Service . . . . .	A-1
The German Action to Occupy Rotterdam and the Aerial Attack of May 14 . . . . .	A-2
The Consequences . . . . .	A-3
The Organization of the Rotterdam Fire Department . . . . .	A-12
Efforts of the Voluntary Fire Department of Rotterdam After the Great Aerial Attack of May 14 . . . . .	A-21
Losses of the Rotterdam Fire Department . . . . .	A-24
Eyewitness Accounts . . . . .	A-25
Comments on the Foregoing Eyewitness Accounts . . . . .	A-40
The Renewed Superiority of Effects of Fire . . . . .	A-44
Additional Observations . . . . .	A-55
Appendix (to Rumpf's Report) . . . . .	A-71

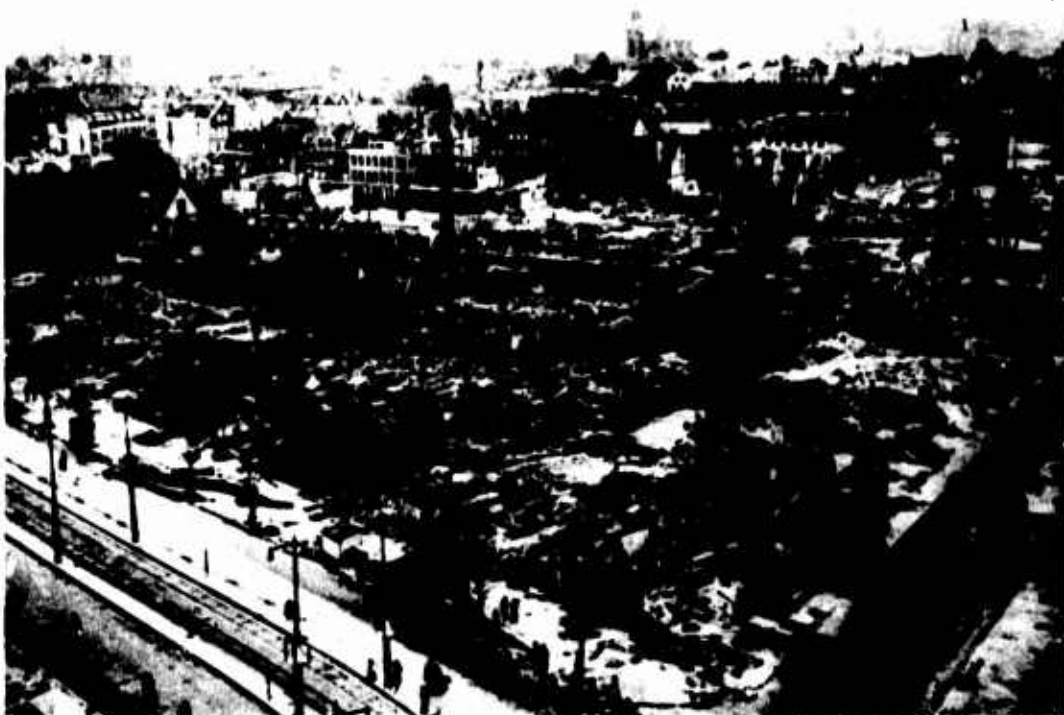
Approximately 75,000 people were without housing. One-sixth of the buildings in the city were destroyed (see Pictures 3 through 8). These data are not accurate since the city government lost all statistics and files in their archives.

**Picture 4** VIEW FROM THE SKYSCRAPER

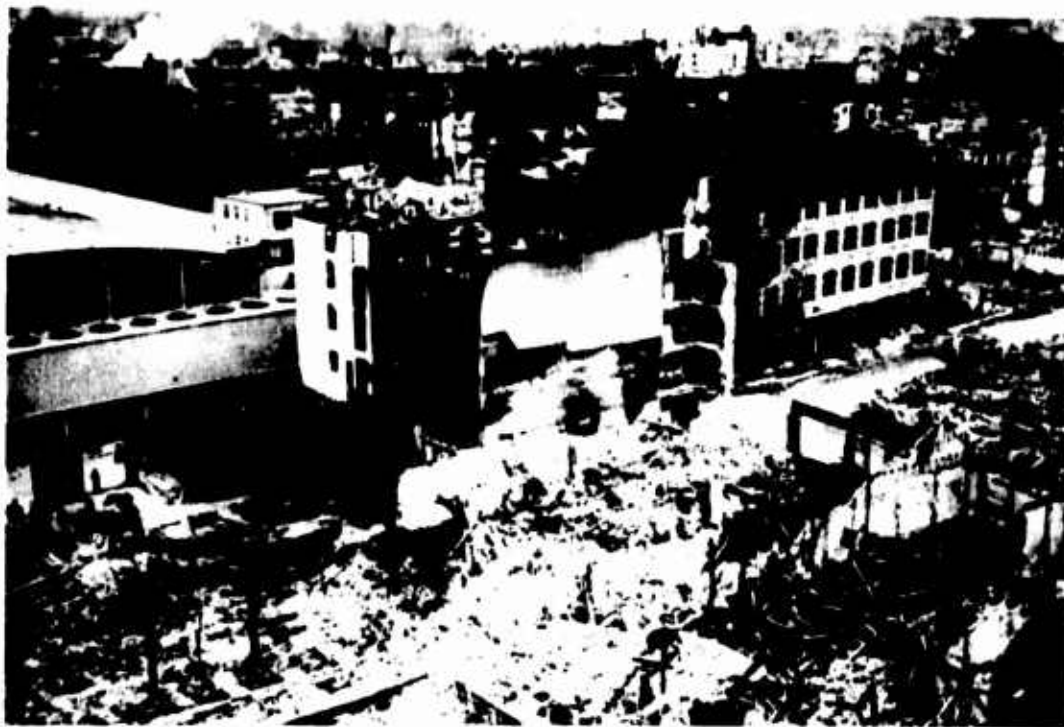
**Picture 5 VIEW FROM THE SKYSCRAPER**

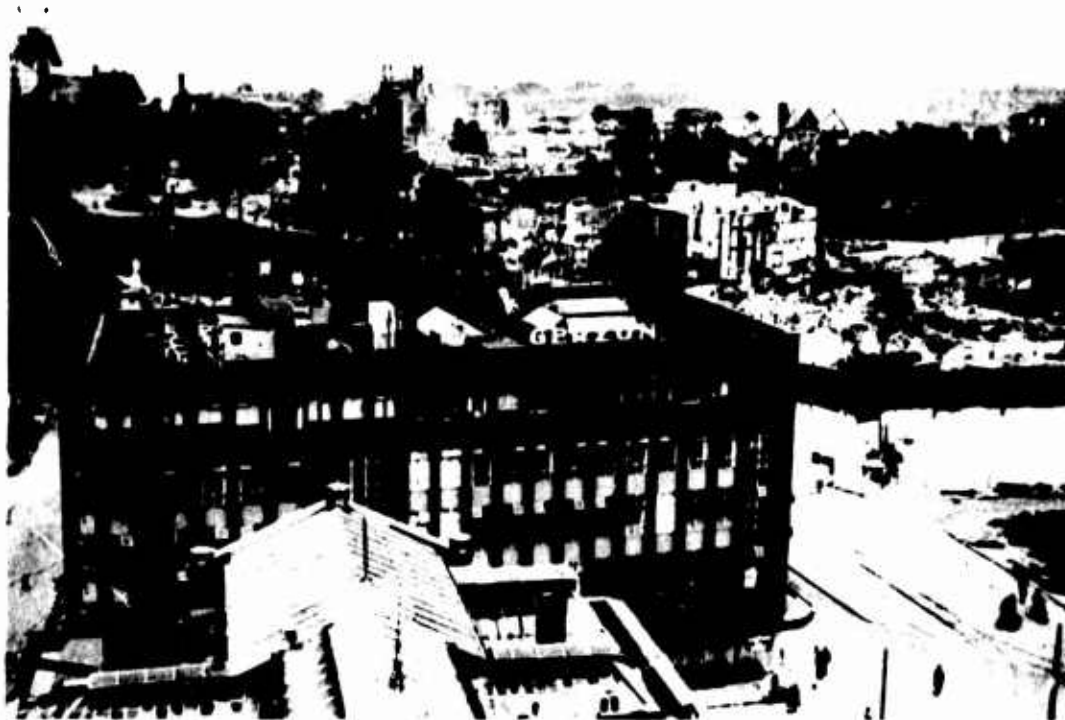
**Picture 6 THE UNDAMAGED DEPARTMENT STORE GERZON AND THE GREAT MAAS BRIDGES  
IN THE BACKGROUND**

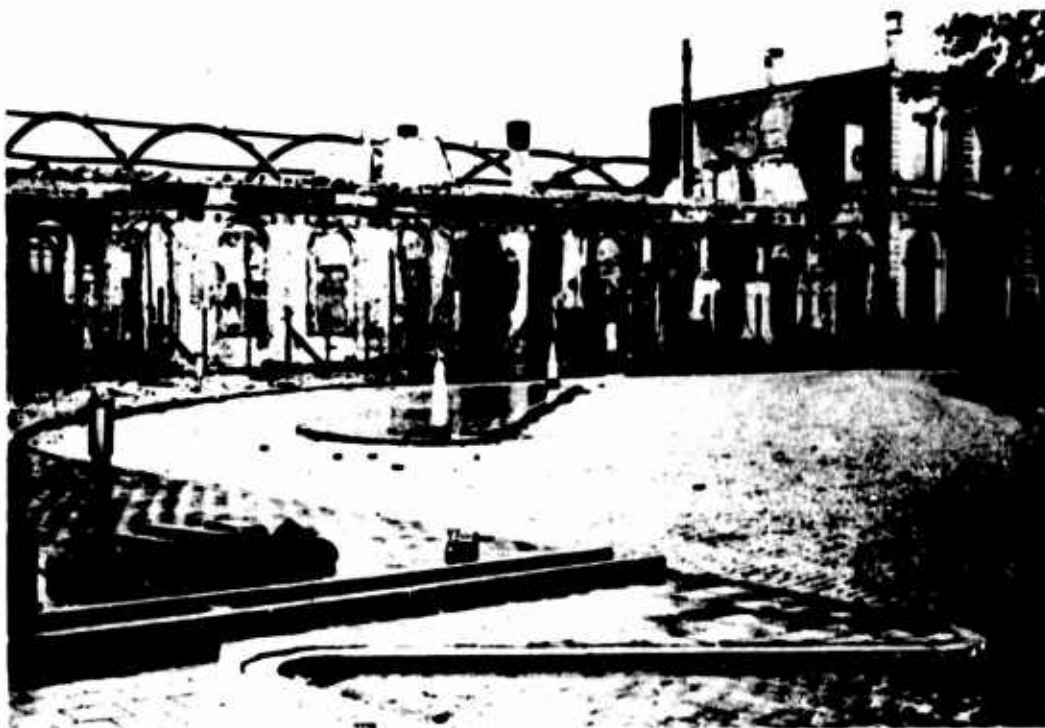
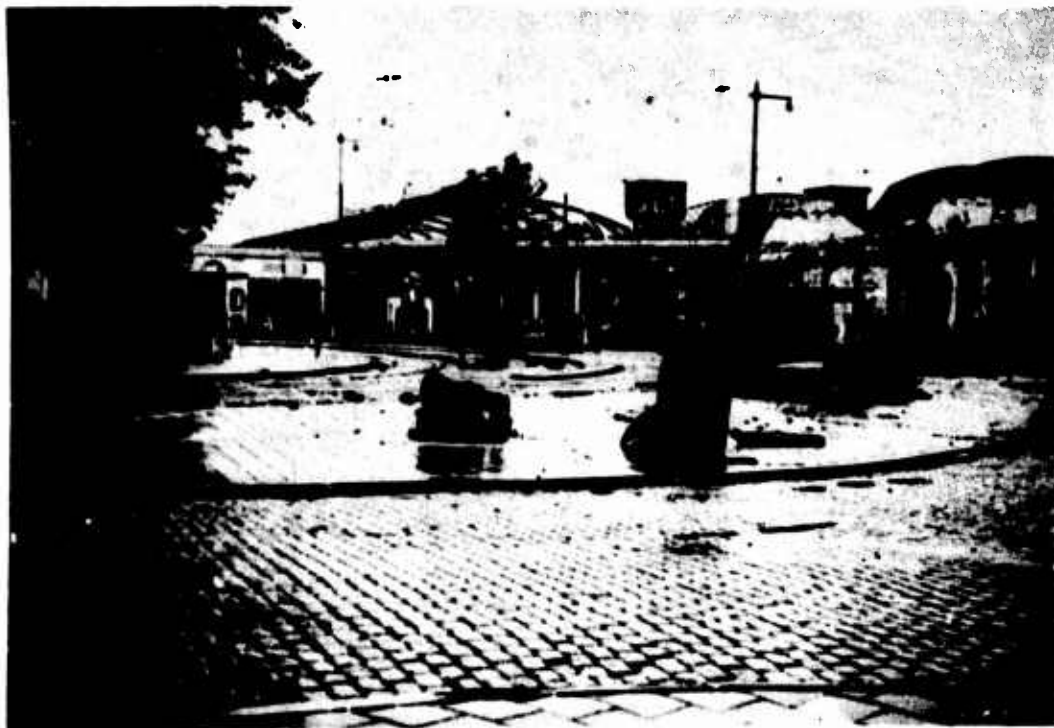
the water works, but there was an unlimited amount of water available from the canal at Stationssingel, directly behind the station (see Pictures 19 to 24).

Pictures 21, 22 THE DELFTER POORT RAILROAD STATION

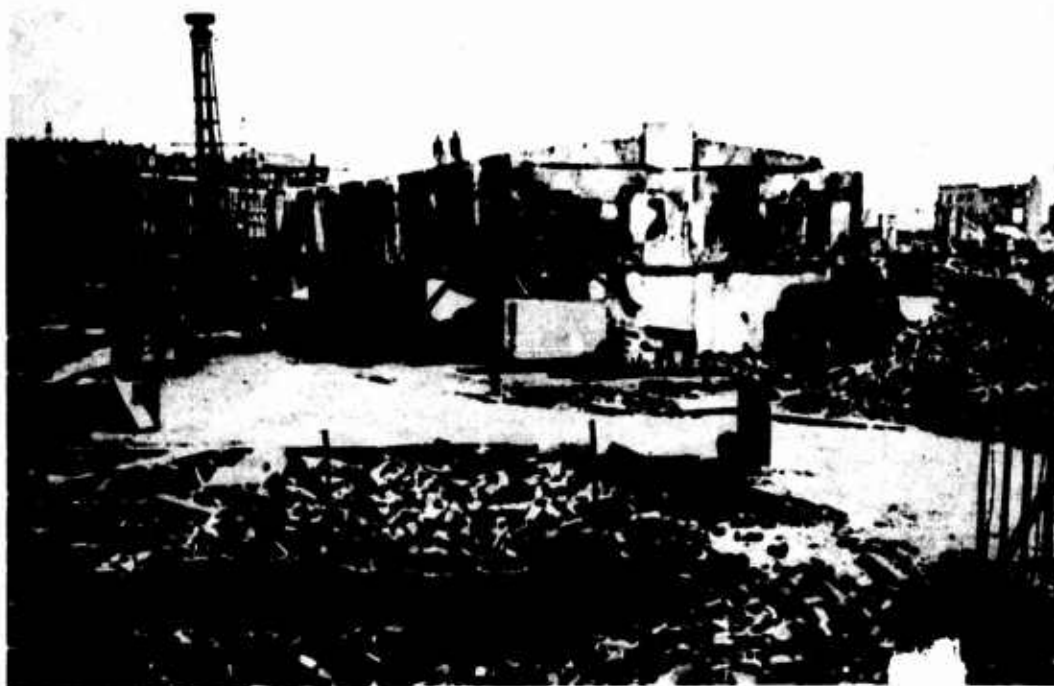
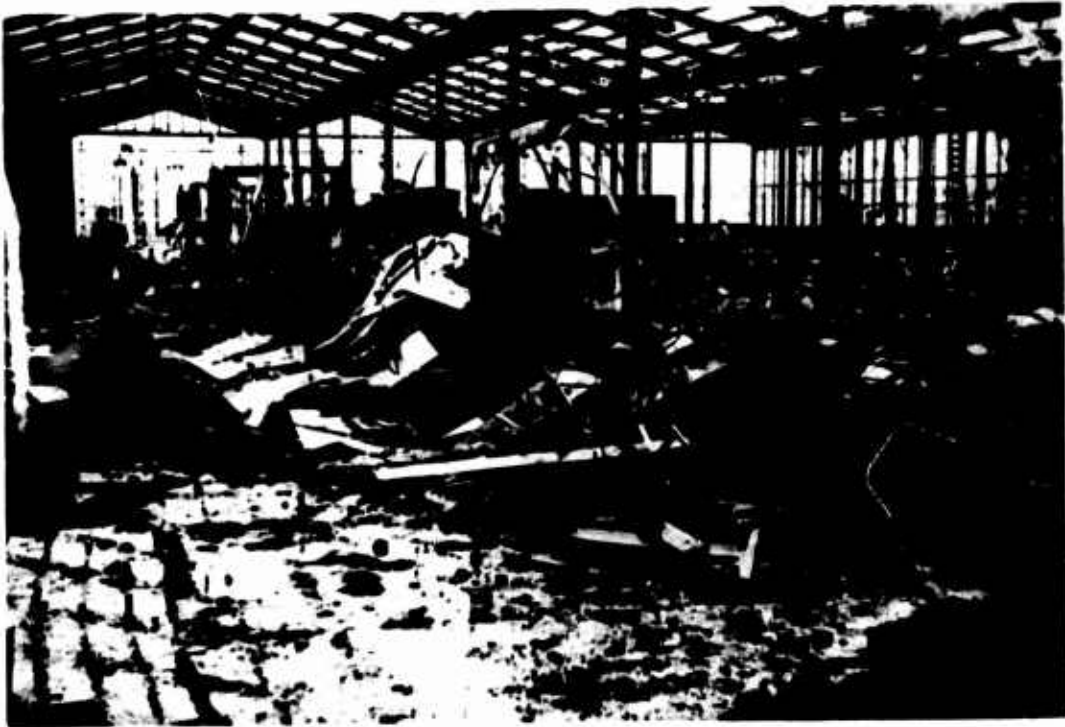
Pictures 23, 24 THE DELFTER POORT RAILROAD STATION

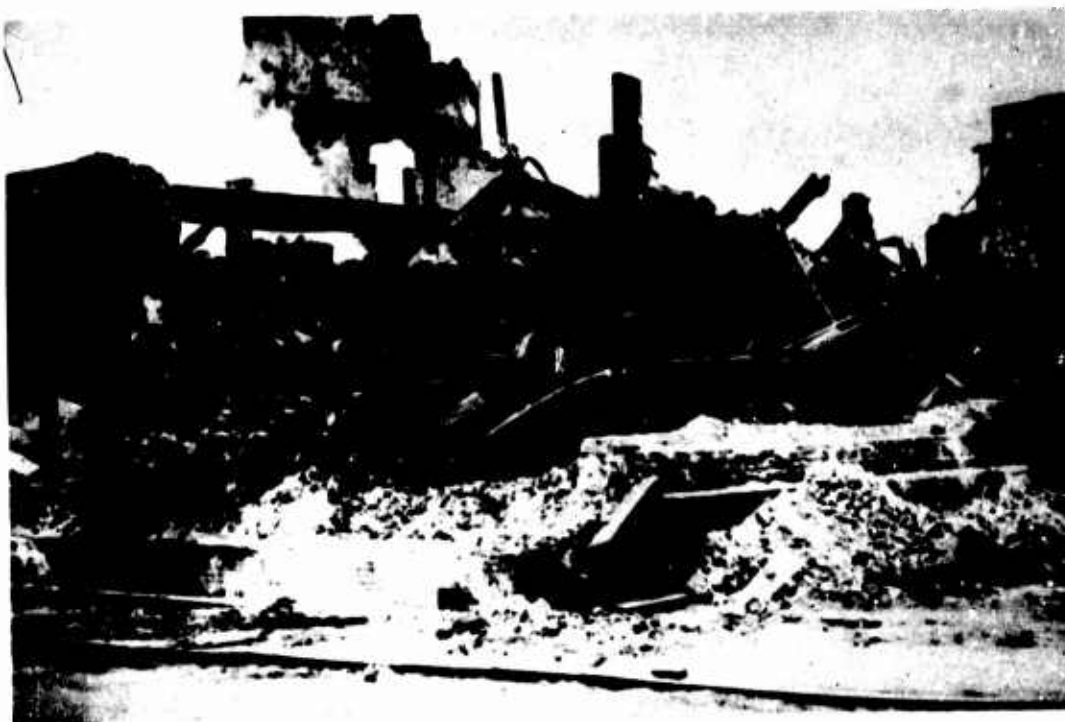
A characteristic of fire ruins is the tangle of twisted metal. With the exception of a few buildings which received a direct hit by a high explosive bomb and were left standing without burning (see Pictures 25 to 30), all parts of the field of ruins show the typical destruction by fire, with the metal supports twisted by heat and fire (see Pictures 33 to 42).

Pictures 35, 36 TWISTED STRUCTURAL STEEL, CHARACTERISTIC OF STRUCTURES  
DESTROYED BY FIRE

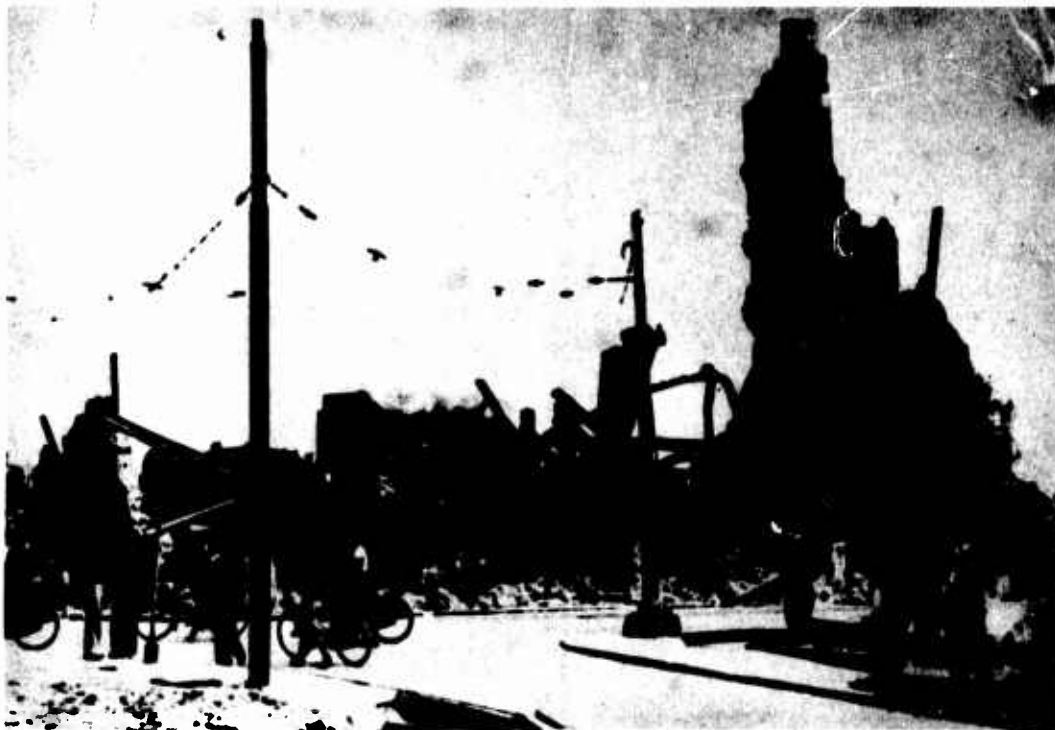
**Figures 39, 40 TWISTED STRUCTURAL STEEL, CHARACTERISTIC OF STRUCTURES DESTROYED BY FIRE**

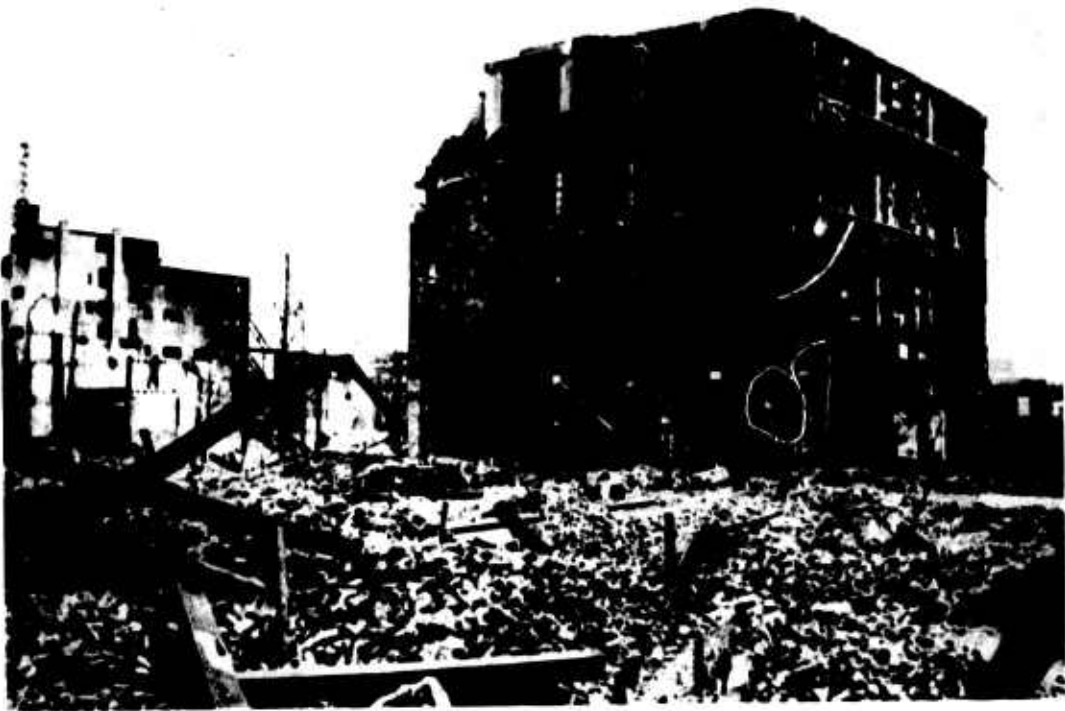
Also, from the outside the countless blackened facades of remaining buildings show plainly that the destruction was accomplished by fire and not through the force of high explosive bombs (Pictures 43 to 55).

**Picture 54 SOOT-BLACKENED STRUCTURE**

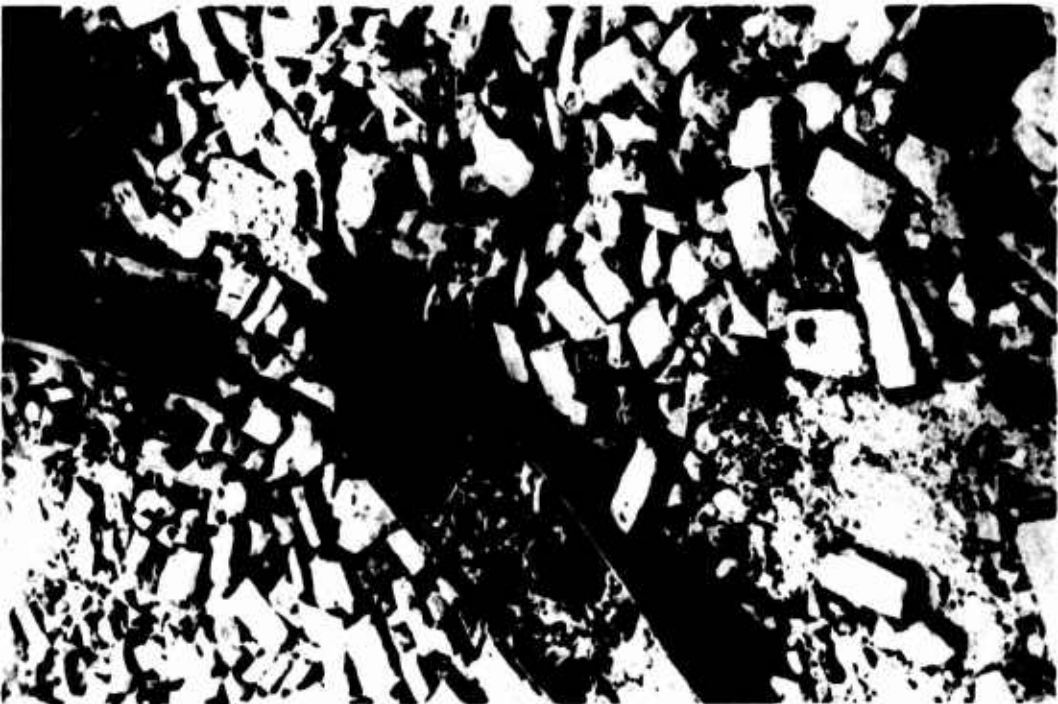
**Picture 61 BRICK DAMAGE FROM EXTREME HEAT**

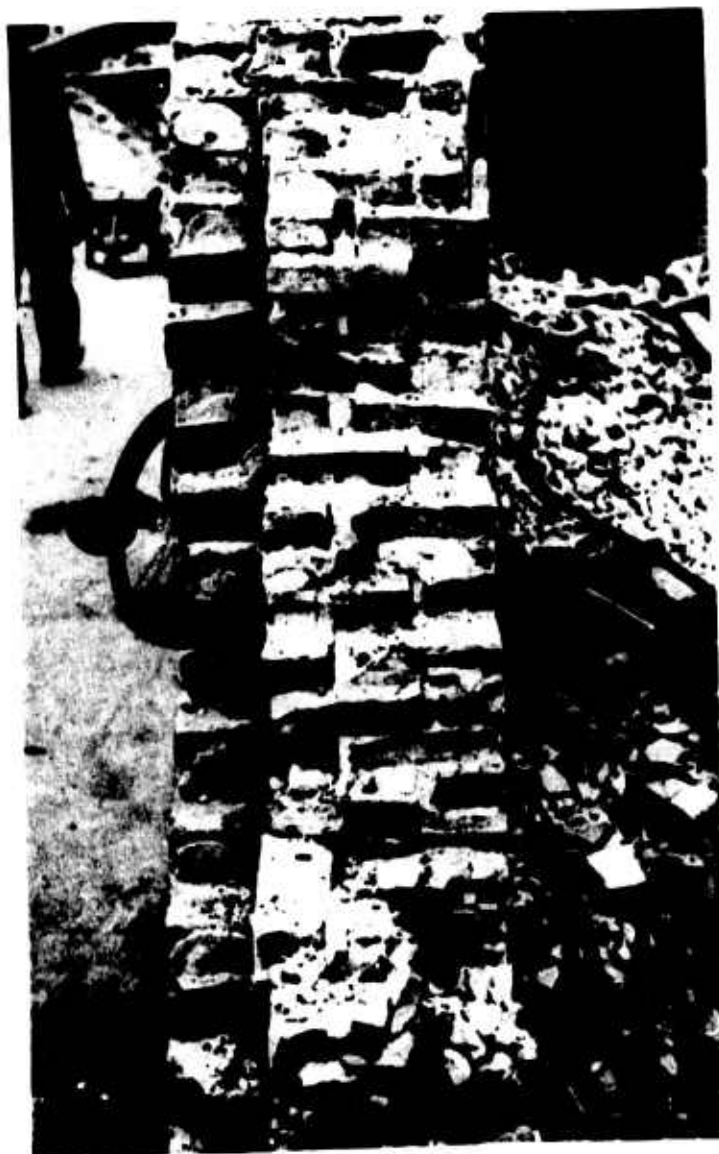
You can see in Picture 75--as hard as this may be to understand for a German--two outer walls of two neighboring buildings, where the left one has the thickness of only 0.5 stone or 8.5 centimeters.

**Picture 75 ILLUSTRATION OF DUTCH BRICK WALL CONSTRUCTION**

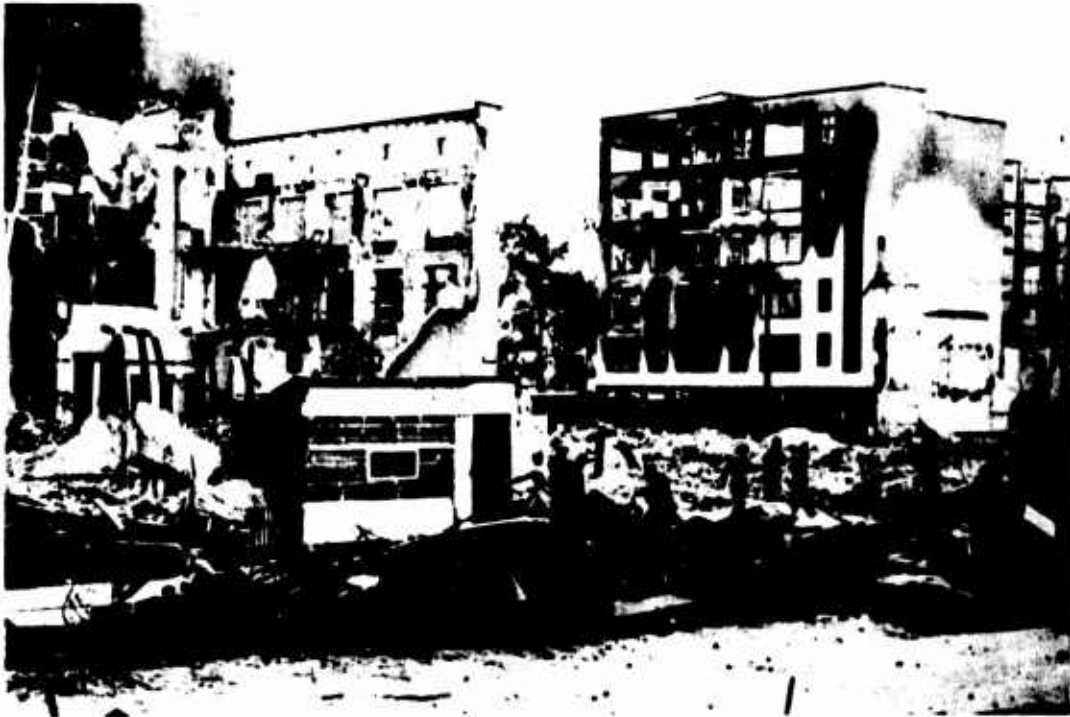
In contrast to the above-mentioned buildings made from Dutch brick, the buildings made from German brick stood up well in the fire and even survived better than concrete buildings. Picture 78 shows a warehouse and Picture 79 a department store (Brennigmeier). Both were gutted completely and all fixtures and merchandise burned. The German brick survived without crumbling and without sintering, thereby preventing collapse of the walls. In Picture 80, to the right, a Dutch clinker building can be seen with the hollow stone ceilings collapsed but with the outer walls left standing. On the left is the collapsed office building of the Rotterdam telephone company, built of Dutch brick. Pictures 81 and 82 plainly show the destruction as related to building methods and materials. In the foreground are totally destroyed residences and business buildings built of Dutch brick. The church in the background in Picture 81 and the office building in Picture 82 are built with brick and brick and sandstone, respectively.

**Picture 80** RELATIVE FIRE-RESISTANCE OF GERMAN AND DUTCH BRICK CONSTRUCTION

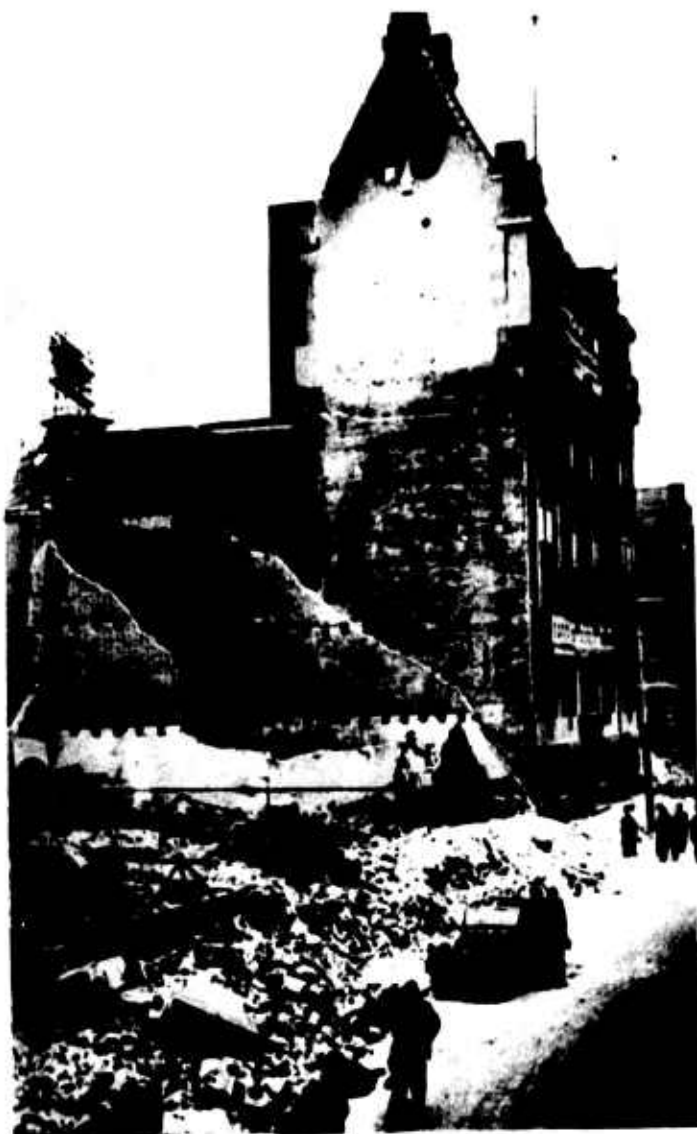
**Picture 82 RELATIVE FIRE-RESISTANCE OF DUTCH AND  
GERMAN BRICK WALL CONSTRUCTION**
